1st architectural site review report

Re: 93 John Street, Markham, ON

Re: Existing structure at 93 John Street, Markham, Ontario

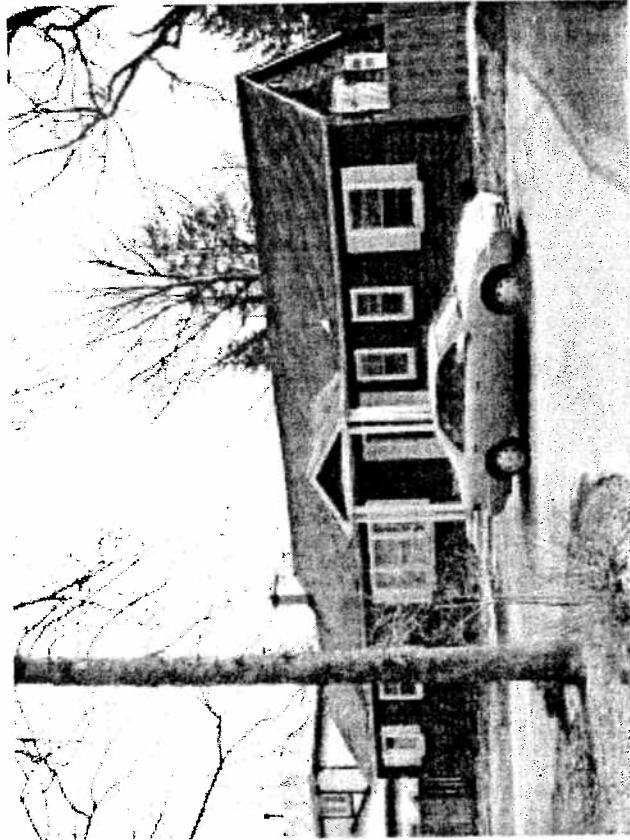
Comments: Treed setting and shingle siding lends a rustic cottage air.

Description: Four-bay cottage with 2-bay extension on the left. Left bay of main house has an A-B-A triplet window. Second bay has front-gable entry portico supported on slender square triple posts. Third bay has two small windows, and right bay has a large window. Decorative shutters on front door and three of the six window openings. Landscaping is mature, with large trees. Circular driveway in front.
