March 8, 2016

Reference No. 1613

Re: Structural Assessment
6840 14th Avenue
Markham, Ontario

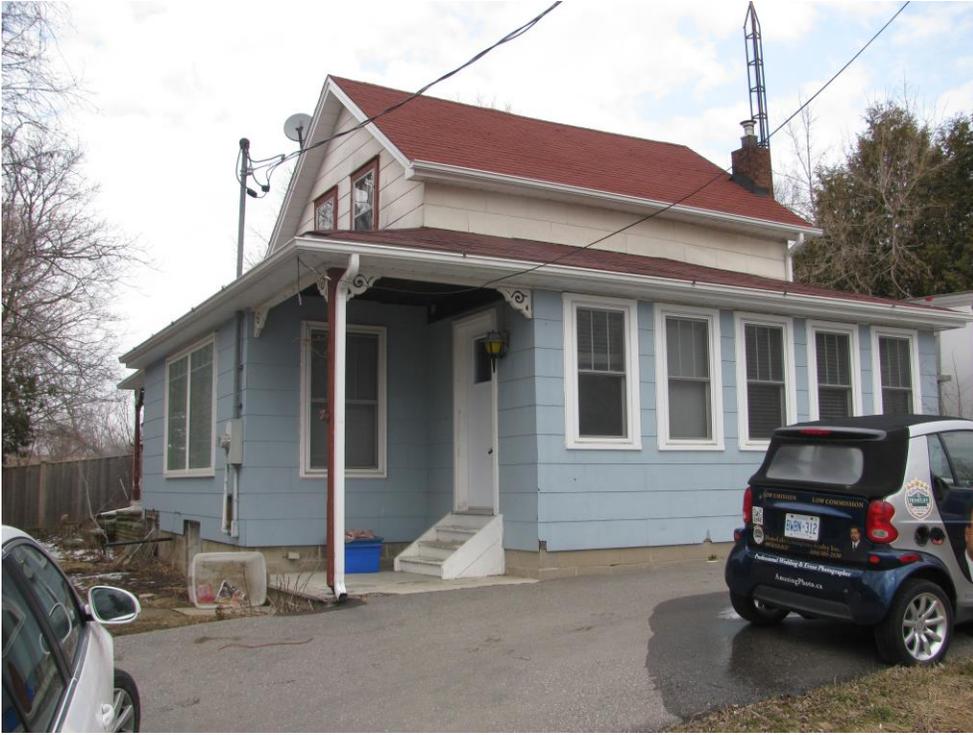
The existing house is a two story wood frame structure with asbestos siding as shown in Photograph 1 taken on March 7, 2016. The house and additions are all cased in hard asbestos tiles which were popular in the 1950's. The tiles were assumed to be asbestos based and the assumption may be verified by testing.

The two story house appears to have been modified by enclosing areas at the front, rear and the west of the house as seen in Photographs 1 and 6.

Photograph 1 showing the front of the house at 6840 14th Ave., on Mar 7, 2016.

The asbestos tiles should be removed and disposed in the manner required by the Ministry of Environment and Climate Change (MOECC).

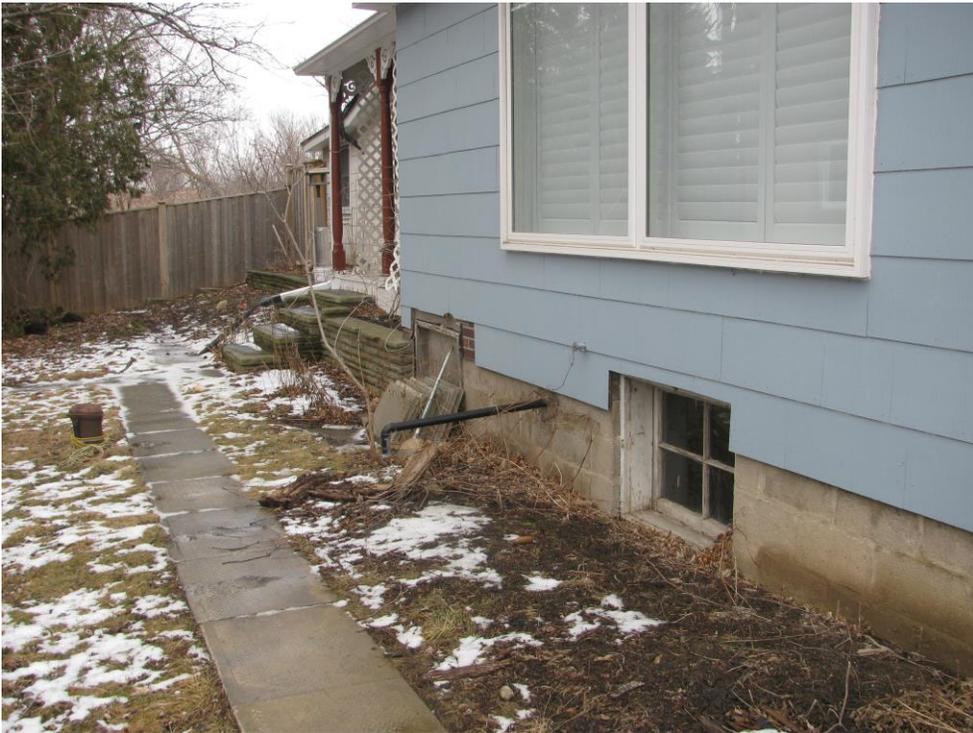
Photograph 2 is a view of the west wall of the house with the rear addition at the back. Photograph 3 shows the foundation concrete of the rear addition.

The well is seen in Photograph 2. Photograph 3 shows the rough concrete foundation supporting the rear addition. The concrete block wall foundation in the front of the house shows signs of distress as seen in Photograph 4. Where the asbestos tiles have broken in a couple of places, the underlying asphalt tar paper with a brick pattern was evident.

Photograph 2 showing the west side of the house on Mar 7, 2016.

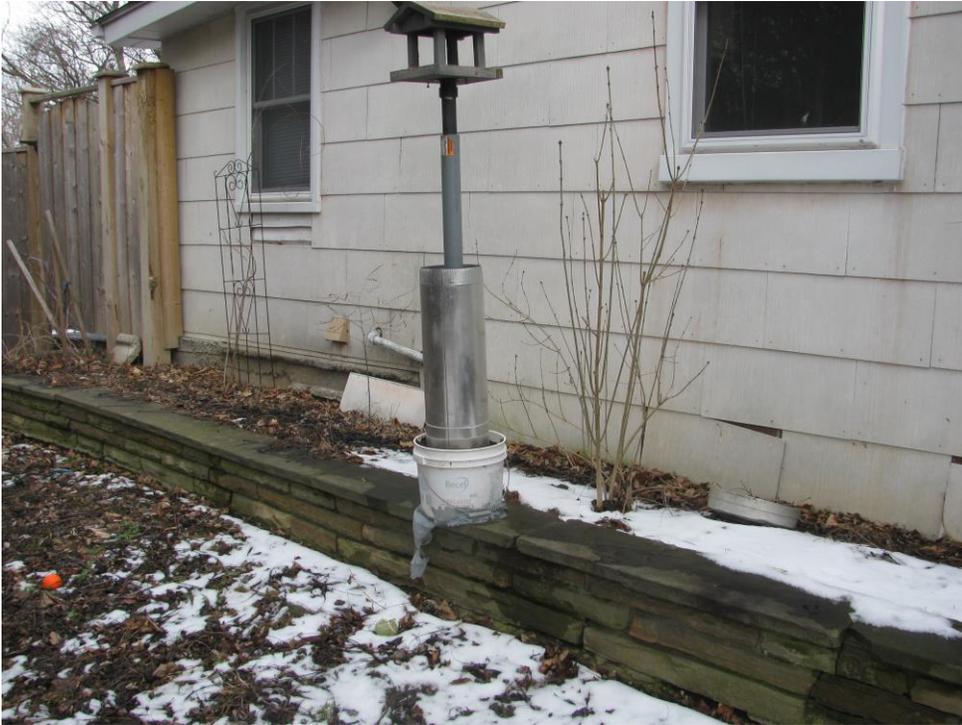
Photograph 3 showing the rear addition on Mar 7, 2016.

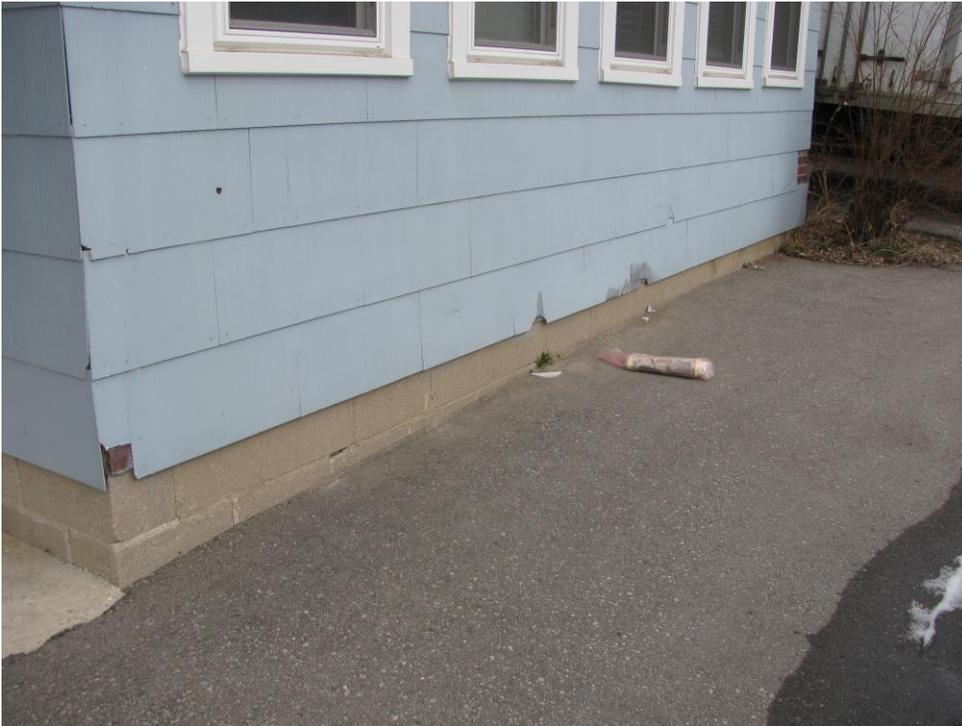
Photograph 4 shows the foundation of the front of the house taken on March 7, 2016. Photograph 5 shows the view of the rear addition and the house. Photograph 6 shows the east side of the house and rear addition.

It was reported that the floor in the second level is rather uneven suggesting some structural distress possibly due to settlement of the foundations.

The house appears to have been constructed in phases over a period of time and the foundation may have settled in some locations.

Photograph 4 showing the front wall of the house on Mar 7, 2016.

The foundations should be stabilized and repaired accordingly. The wiring, plumbing and insulation should all be upgraded to current standards. The chimneys would certainly need major repairs.

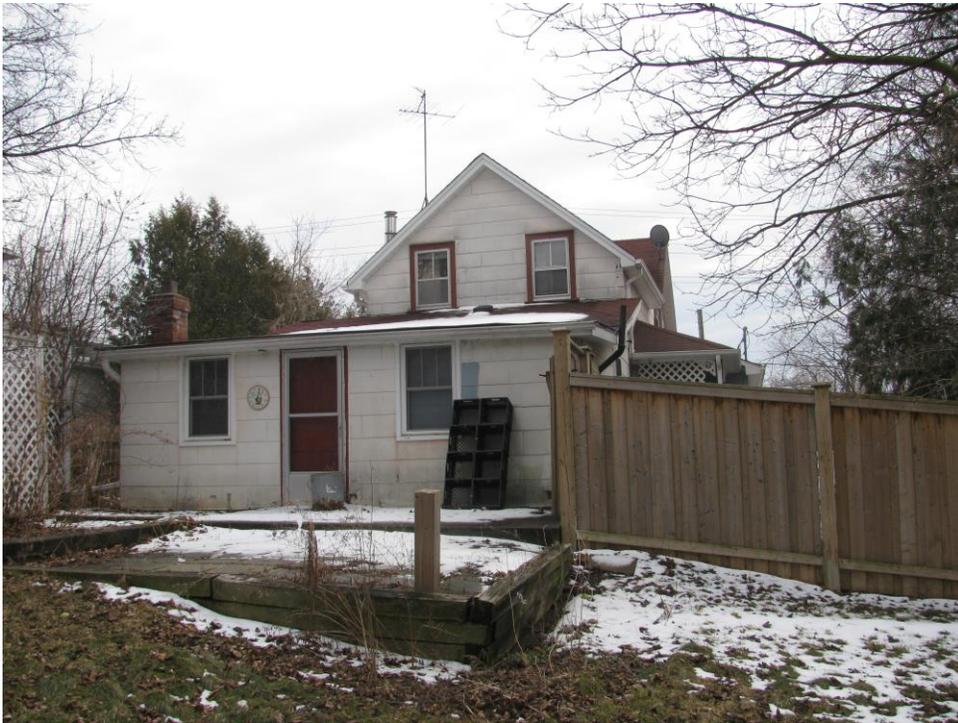
Photographs 5 and 6 show the rear addition. It is evident that the rear addition was built at a later time than the main house. The two brick chimneys showed severe distress at the top.

Photograph 5 showing the rear view of the house and addition on Mar 7, 2016.

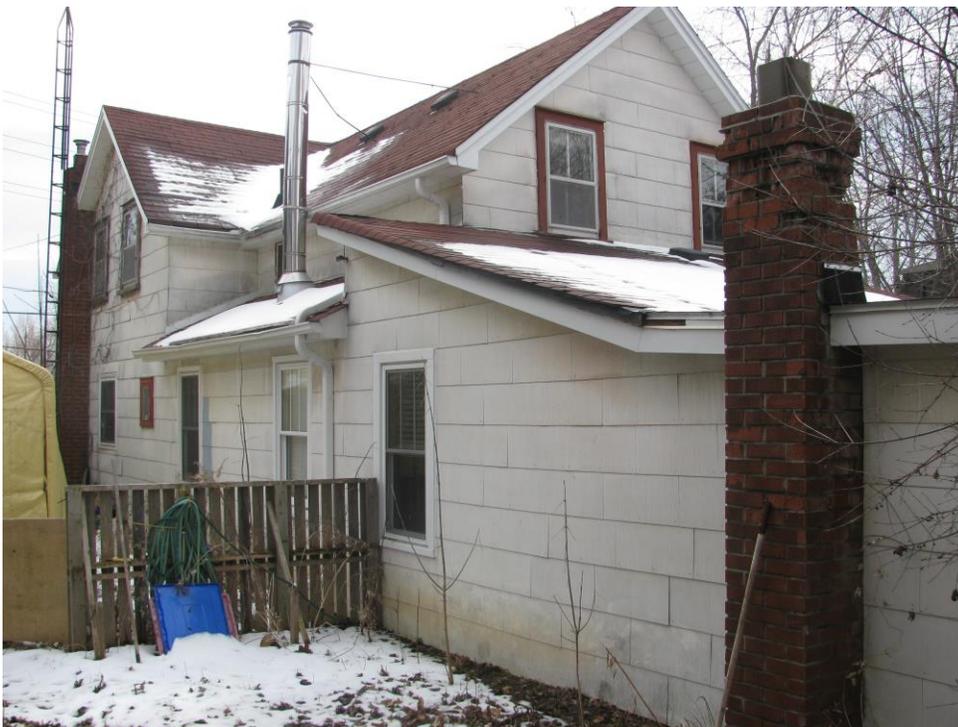
Photograph 6 showing the east side of the house and addition on Mar 7, 2016.
