SUBJECT: Eligibility of Reverend Jenkins House for Relocation
to Markham Heritage Estates
11022 Kennedy Road

PREPARED BY: Peter Wokral, Heritage Planner, ext. 7955

Re: Property Standards Order #16 134214
11022 Kennedy Road, Markham, Ontario
Structural Condition Evaluation

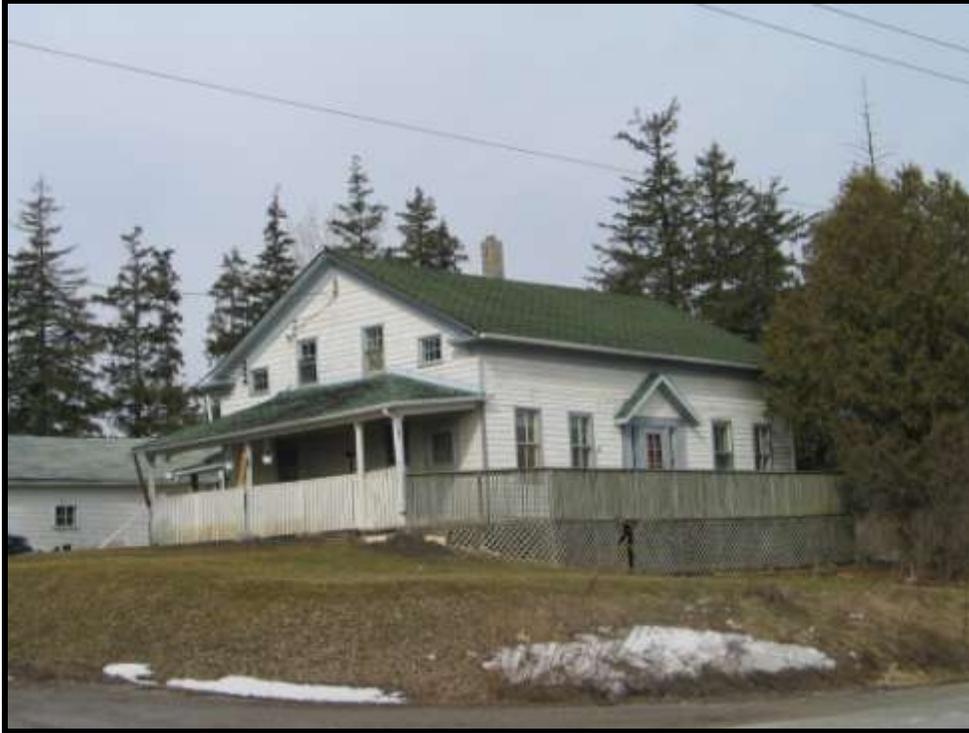
The Reverend Jenkins House in March 2004

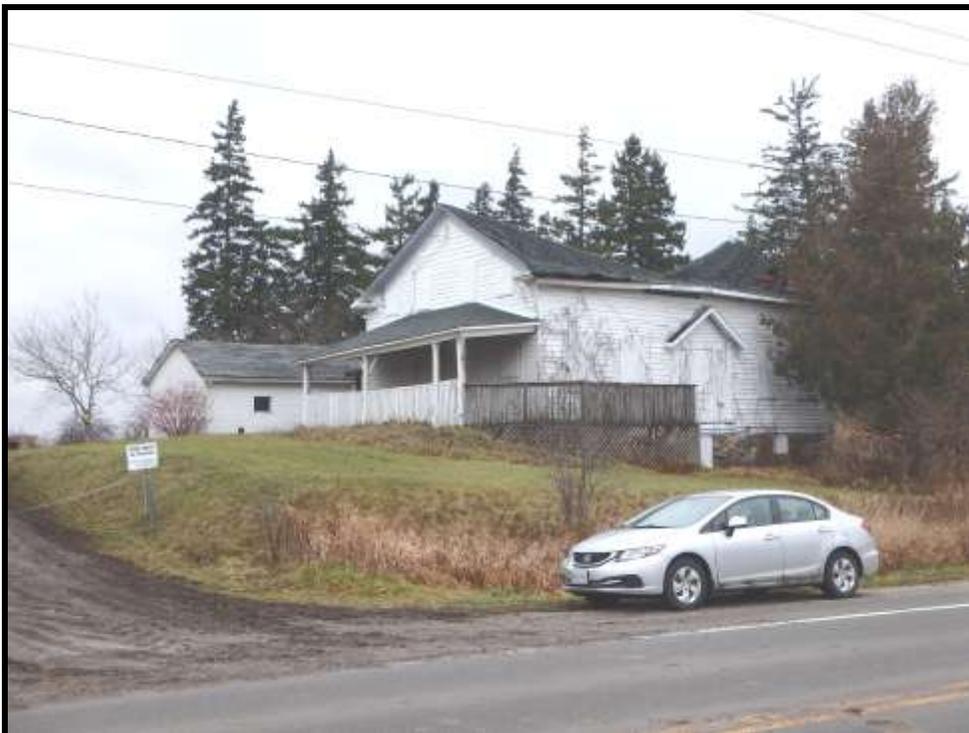
In the autumn of 2016, a noticeable sag appeared in the ridge of the roof of the Reverend Jenkins house. By November of 2016, a large portion of the roof had collapsed along with the portions of the first and second floor structure. The damage was the result of a large hole in the rear slope of the roof which had gone undetected by the owners or City By-law officers.

The Reverend Jenkins House December 1, 2016

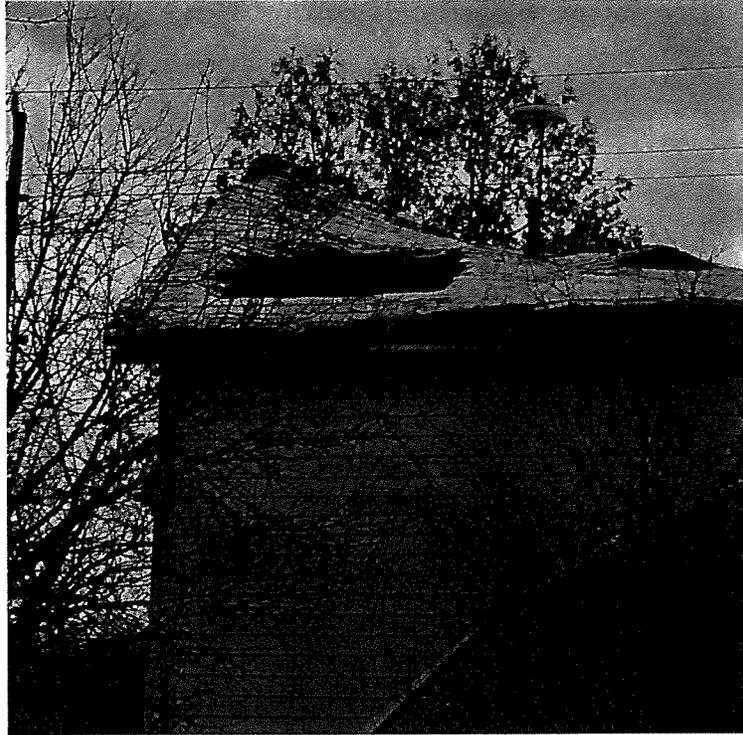
West Elevation

The walls are wood framed and are clad with wood siding. The east wall had bowed out and has lost the support at the roof and second floor. The north and south walls also were out of plumb. The west wall was braced by one storey structure and as a result had not moved similar to the other three sides.

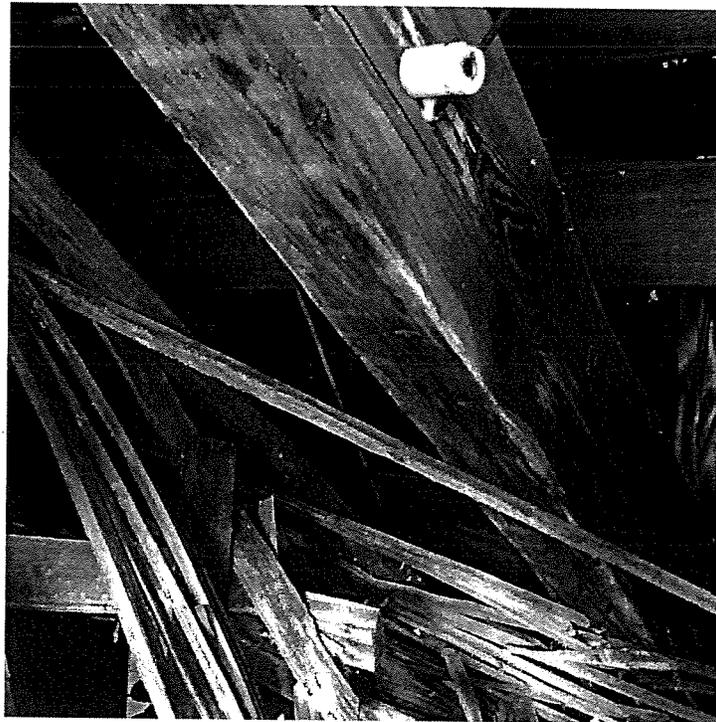
The basement walls are constructed with rubble and brick foundations. We were not able to see large areas of the basement due to safety concerns. Portions of the wood structure from above

ended up in the basement. Brick debris can be seen near the centre of the house, most likely from the brick chimney that collapsed.

The extent of the damage and deterioration of the structure makes it unfit for repairs. The walls have moved to a point that cannot be restored. The foundation walls were not reviewed but it is highly likely that they have suffered frost heaving since the house was not heated for number of years.

Deterioration of basement wall
