Re: Gemcross Developments (Con-Strada Aggregate Recycling Facility) 350 Yorktech Drive; Your file # **ZA-08-119862**

Re: Strada Aggregates Property Environmental Remediation  
Northeast Corner of Rodick and Yorktech Roads, Markham, Ontario

***Re: Strada Aggregates  
Strada Aggregates Re-Cycling Facility  
Rodick Road and Fairburn Drive  
Town of Markham***

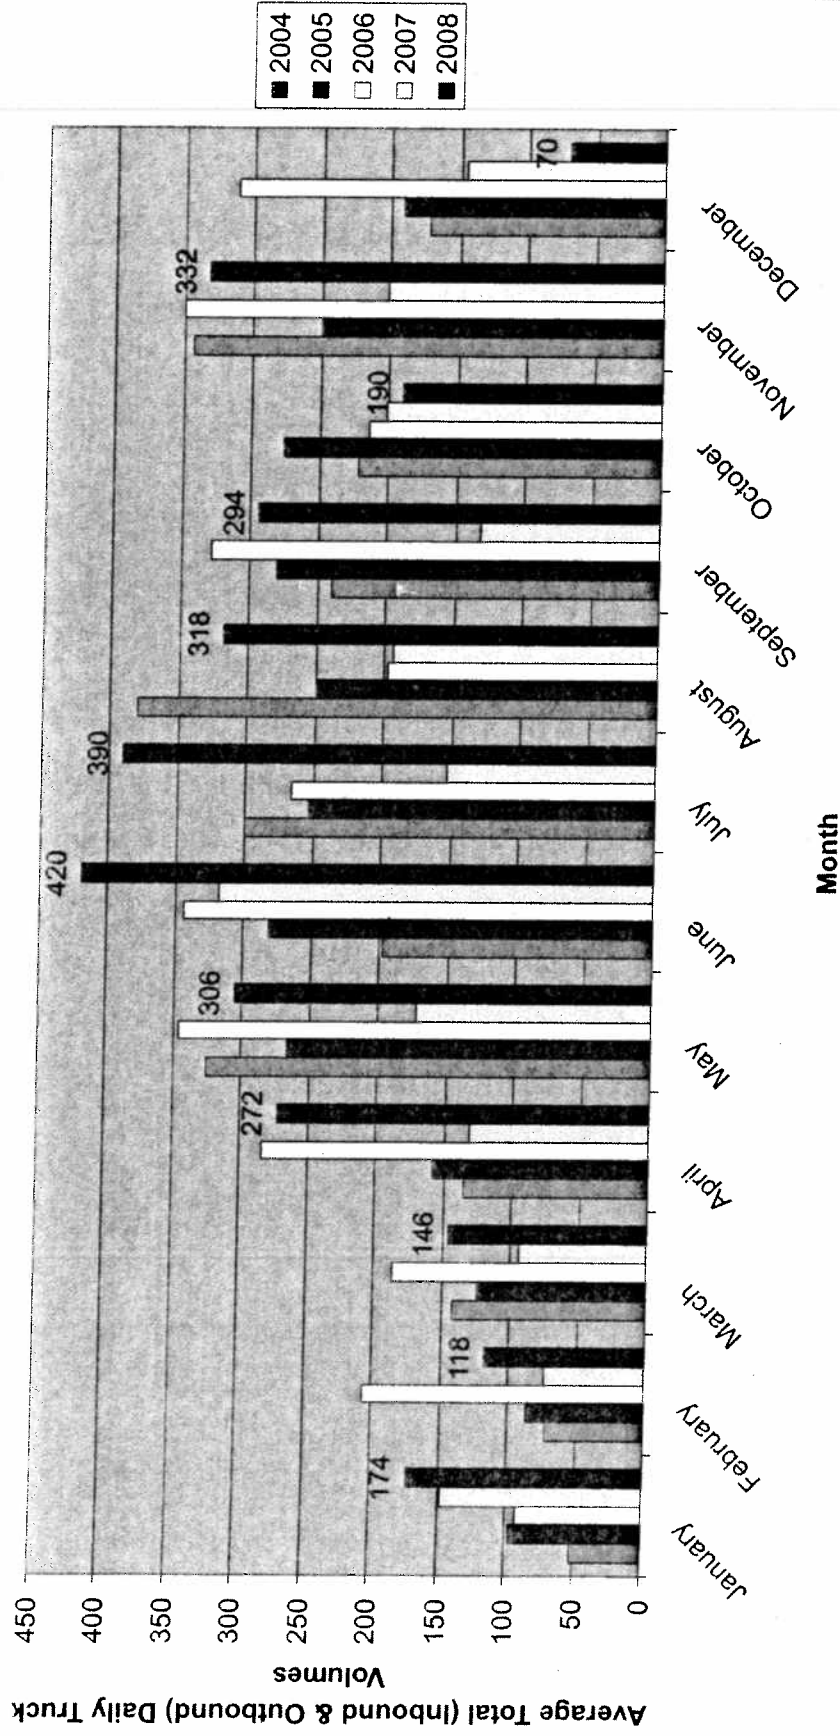
# Average Daily Truck Traffic

The average daily truck traffic (in and out of the site) by month of year is shown in Figure 2. The daily truck traffic by month is presented for years 2004, 2005, 2006, 2007 and 2008.

Although there are minor monthly variations by year it is evident that the majority of truck movements are during the major construction season between April and November.

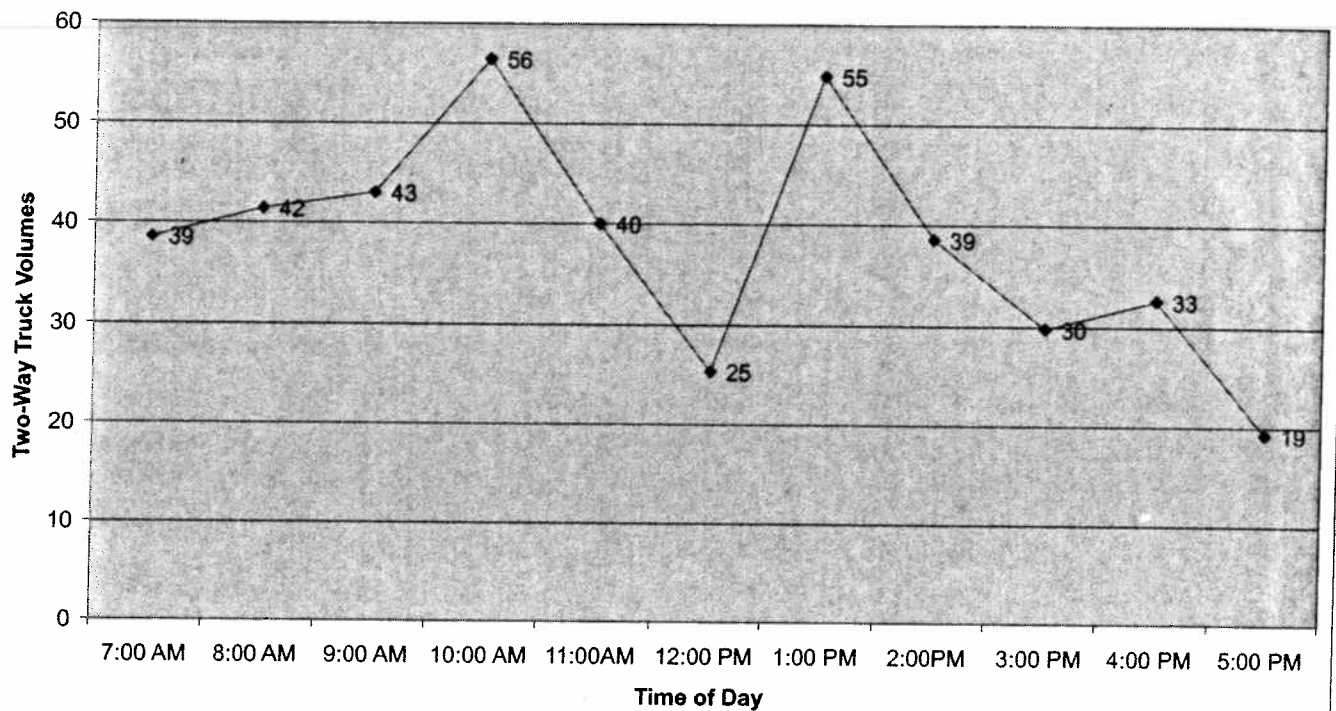
**Two-way Truck Traffic Highest Month Average Day**

The hourly variation of these two days is shown in Figure 3.

The hourly variation of truck flows in these days is very similar. As expected the highest day in the highest month of the year experiences the greatest number of truck movements.

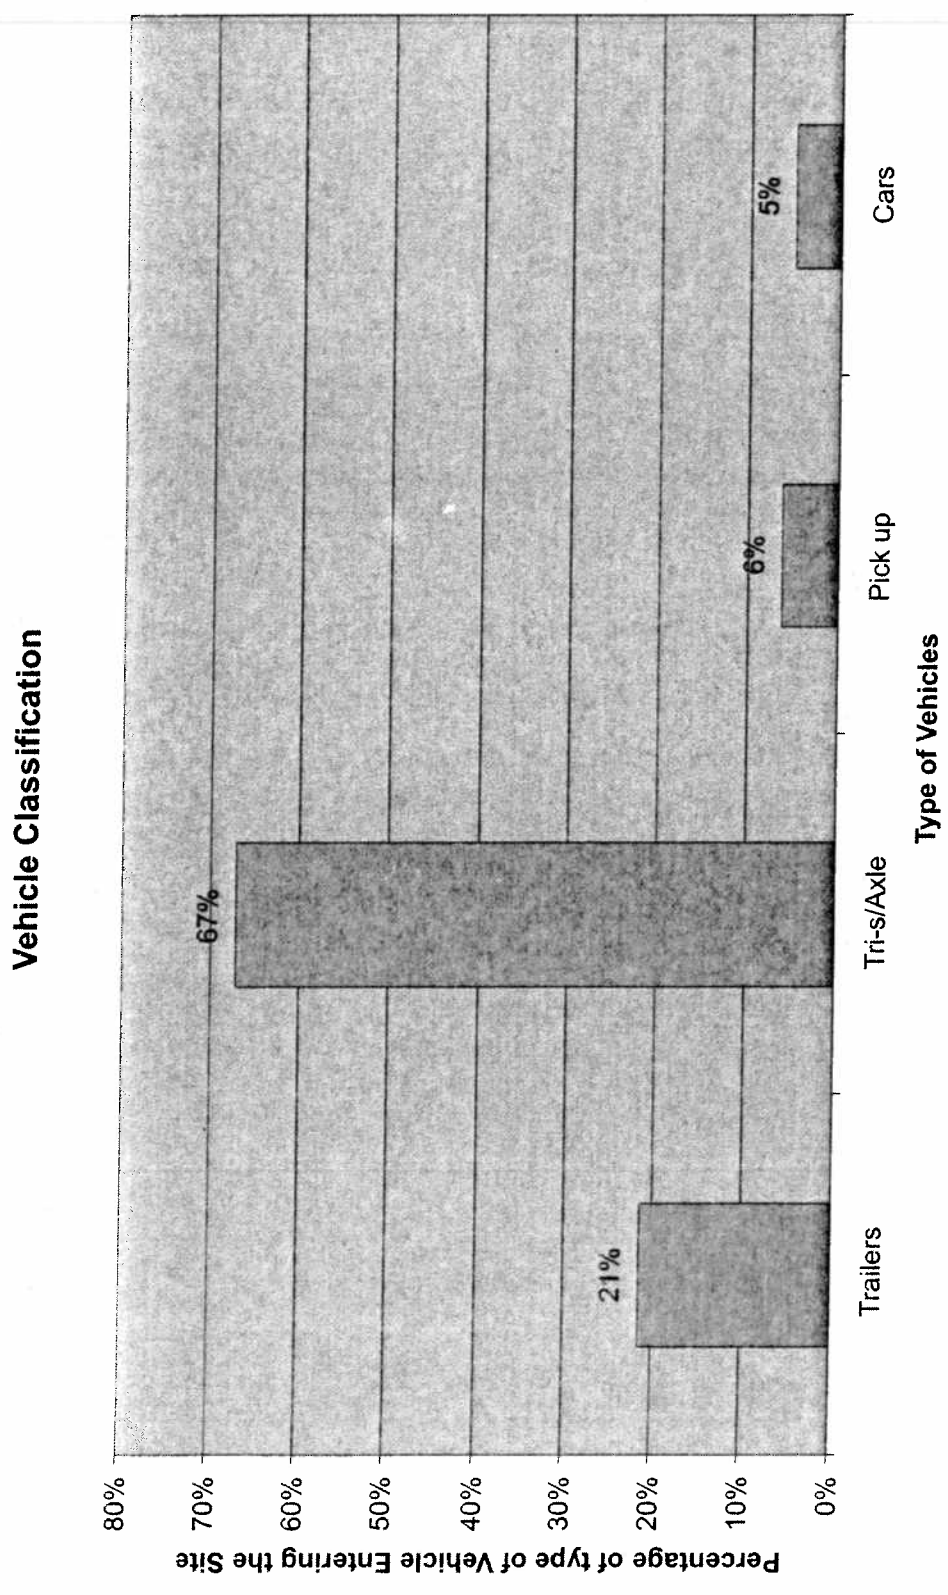
Figure 4

The type of truck using the Strada Aggregates facility is illustrated in Figure 4.

- Trailer – 6 axle Tractor- Triaxle semi-trailer;
- Tri-sAxle – 4-axle Single Unit Aggregate and 3-axle Truck and 4-axle Full Trailer;
- Pick Up – 2 or 3-axle Single Unit Truck;
- Cars – Automobiles or single axle pick-up trucks.

The type of truck used in the Markham operation is considered normal and indicative of similar operations.
